AVRADCOM REPORT NO. 76-45

Engineering Services to Conduct Qualification Testing of Precision Forged Spiral Bevel Gears

Raymond J. Drago **Boeing Vertol Company** P.O. Box 16858 Philadelphia, Pennsylvania 19142

Final Report

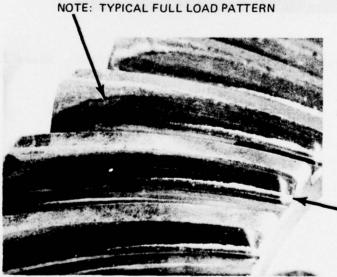
Virtually all Phase I and II test pinions (forged and baseline) had a light hard line in the root at the toe end as shown in Figure 27. This is due to the very high loading applied in these tests. This condition in no way affected the test results or the basis for comparison. The line shown in Figure 27 represents the area of highest unit surface loading and thus, if a surface failure is to occur, this high load area is the most likely origin. It is not surprising, then, to note that the single surface failure which did occur originated, as shown in Figure 29, in this area. Figure 30 presents a map of the failed teeth. No metallurgical reason was found for this failure and a double check of the applied loads revealed no discrepancy. Since no other failures occurred and in view of the good and consistent condition of all other teeth on all other gears, the only logical alternative appears to be to regard this failure as statistical rather than characteristic of the forging process.

Typical Posttest Pinion Tooth Condition, Phases I and II.

> LIGHT HARD LINE TYPICAL OF ALL (FORGED AND BASELINE) PINIONS

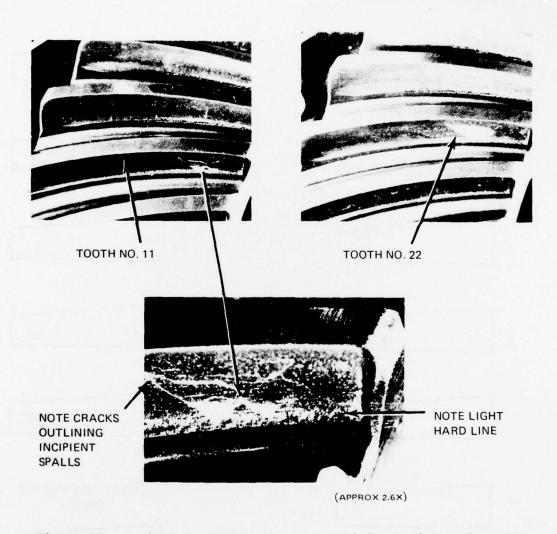
The forged bevel pinion (serial number M108) used in this evaluation is the one which experienced a pitting fatigue failure in the Phase I testing. No metallurgical discrepancy was identified which would account for the failure.

Figure 29. Typical Spalled Teeth, Forged Pinion Serial Number M108.

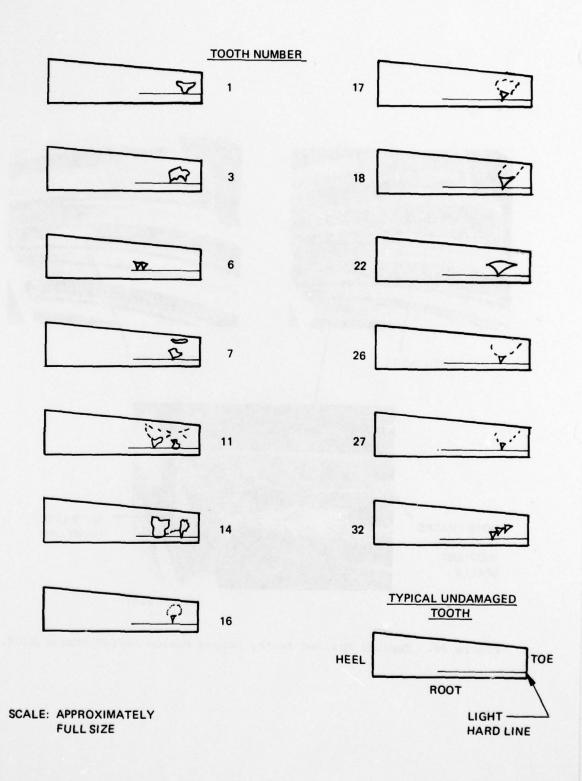
Figure 30. Map of Spalled Teeth on Serial Number M108 Forged Pinion.
